## **V. CORRIDOR AND ALTERNATE ROUTES SAFETY ANALYSES**

This section summarizes the safety analyses performed for State Highway 97 (SH 97) Corridor Study located in unincorporated Kootenai County and within the City of Harrison, Idaho. Collision histories were reviewed to determine where improvements may be warranted. Further analyses were performed to assist in determining and prioritizing the potential roadway improvements within the study area according to the collision rates and number of accidents that occurred within the milepost for the study period. These analyses provide an understanding to East Side Highway District, the Idaho Transportation Department, and Kootenai County of the impact of land use (residential or other development) within the study area.

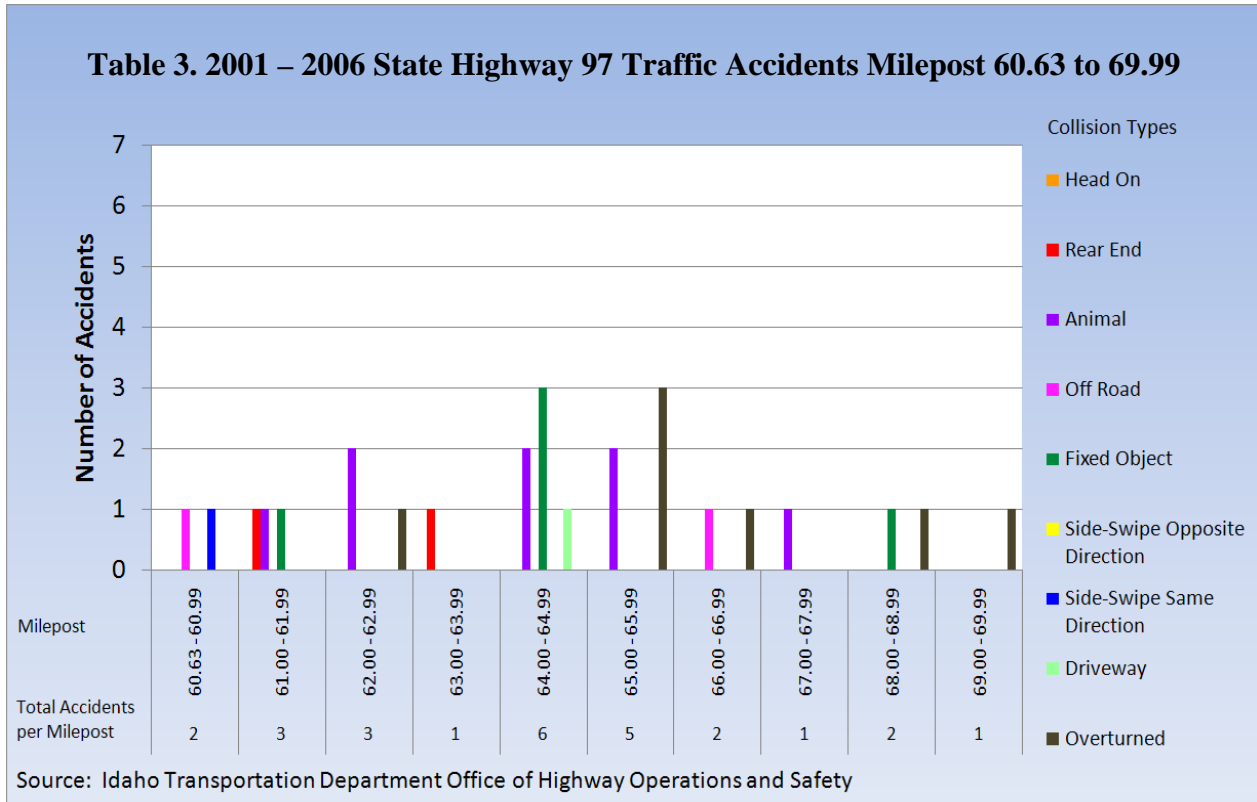
A total of 26 accidents occurred within this segment (Table 3) for the study period. The majority of the accidents that occurred were animal related accidents, with overturned vehicles the second most common accident. This segment of the highway corridor is characterized as rolling terrain with farming being the predominant land use. This segment also includes the city of Harrison.

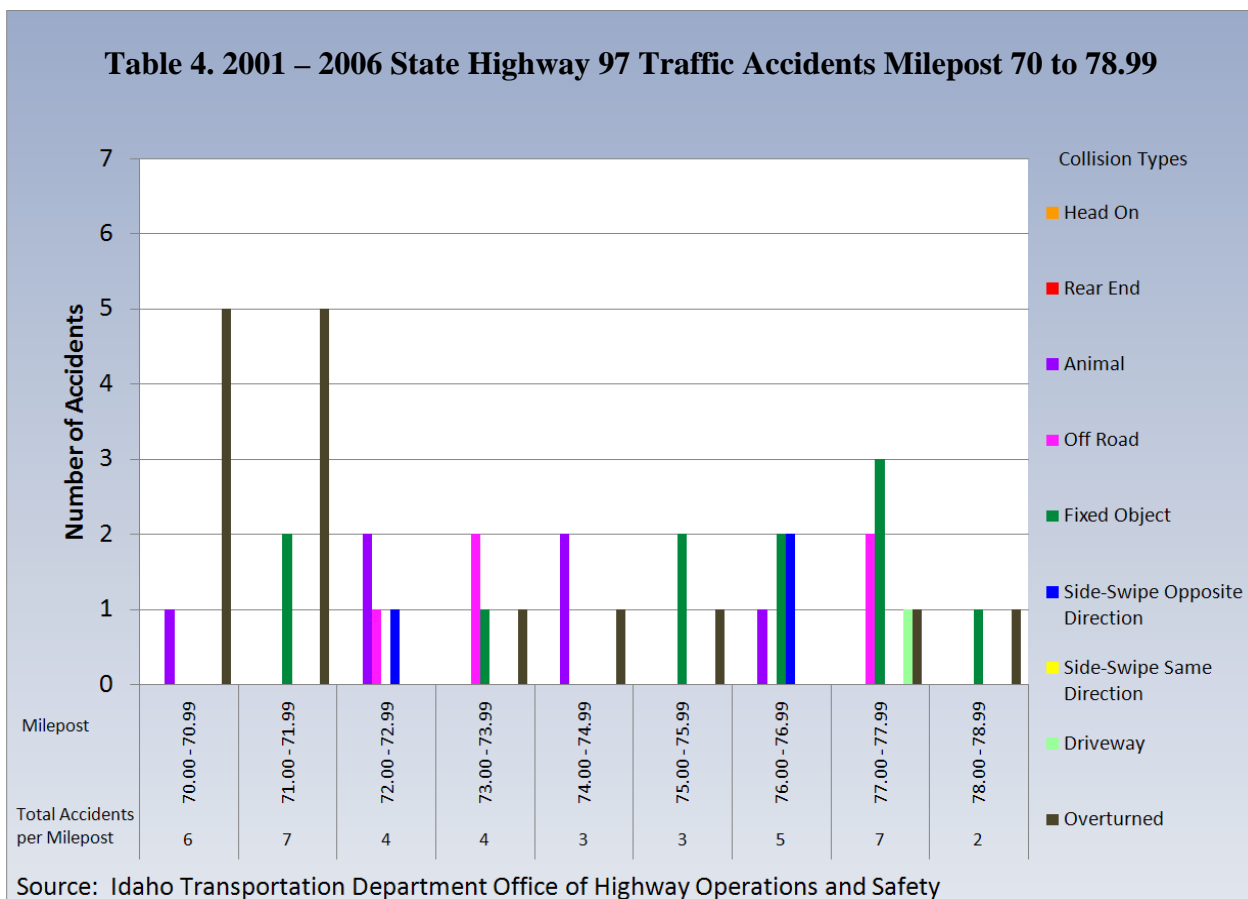
Between milepost 70.0 and 78.99 (Table 4), a total of 41 accidents occurred within the study period. The majority of the accidents (15) resulted in overturned vehicles for this segment. Mileposts 70, 71, 72, and 77 have extreme horizontal curves, which may be a contributing factor to a higher number of incidents occurring within these mileposts. The second most common accident (11) were fixed object related. This segment begins at the Coeur d’Alene River and ends at Carlin Bay. The terrain within this segment includes several tight radii curves as well as the grade changes associated with the Powderhorn Bay Hill grades.

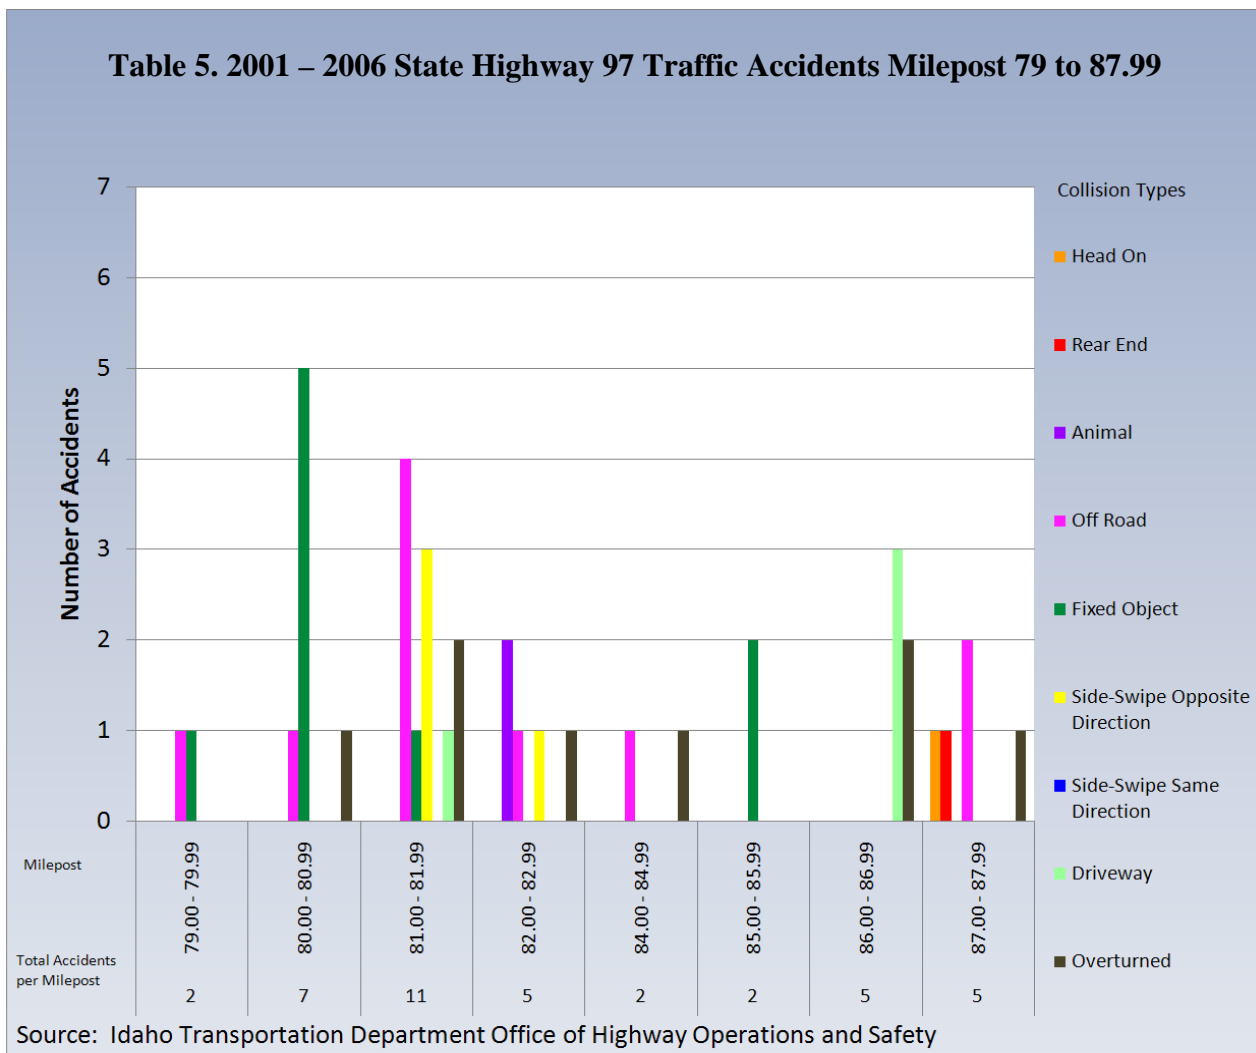
**Table 5. 2001 – 2006 State Highway 97 Traffic Accidents Milepost 79 to 87.99**

Between milepost 79.0 and 87.99 (Table 5), most of the accidents occurred at milepost 81 with eleven accidents. Within this milepost, there are several significant horizontal curves, which may contribute to the higher accident occurrence. The majority of the accidents that occurred were fixed object related and off-road accidents, with overturned vehicle accidents the third most common accident type. Within this segment, there was one fatality located in milepost 81. This segment includes the area north of Carlin Bay to the Arrow Point area. The terrain has several tight curve radii and some intersections have sight distance issues.

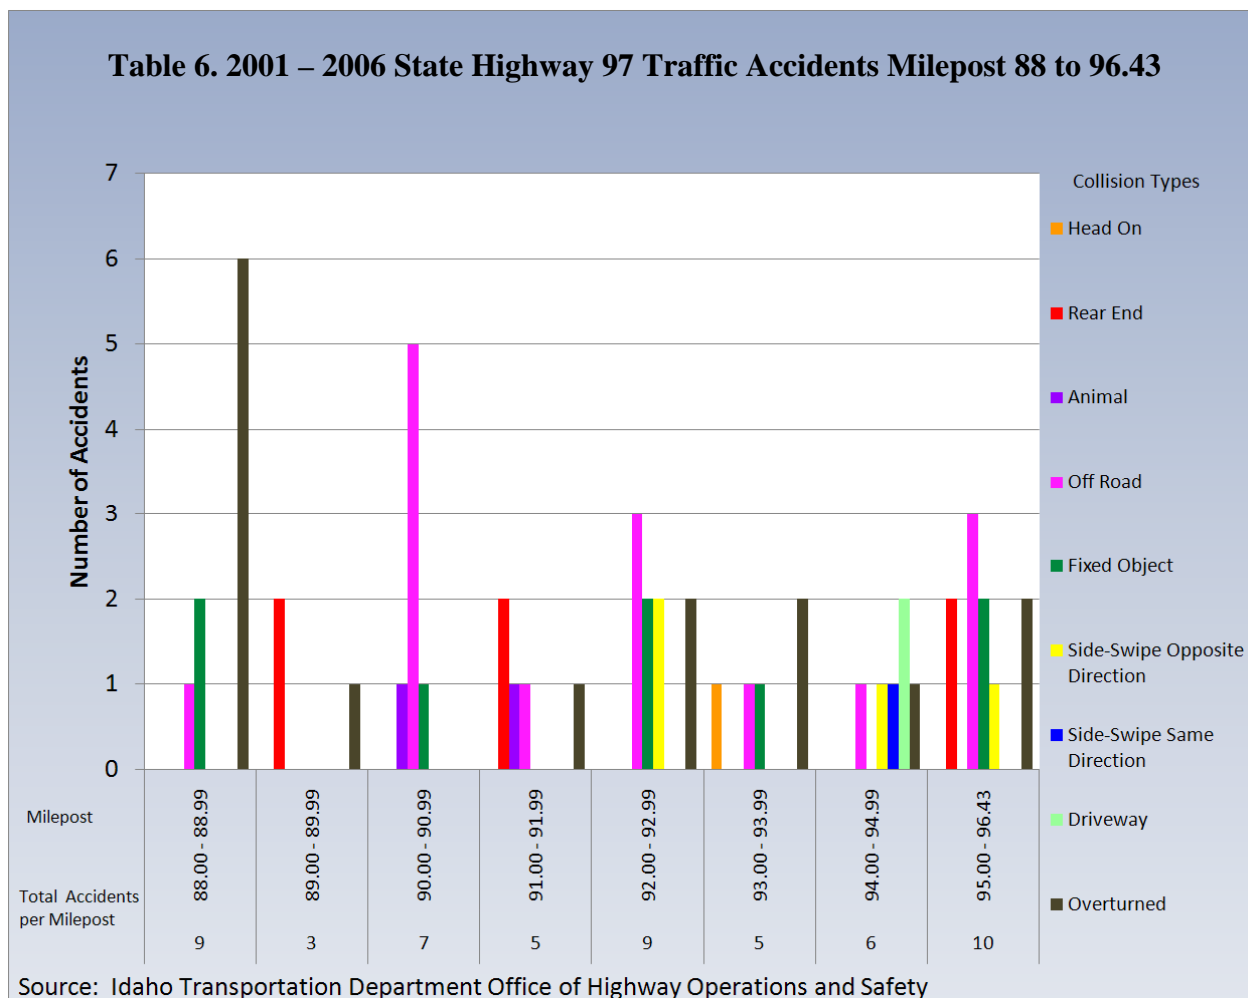
Within this segment (Table 6), 65 percent of the accidents occur at mileposts 88, 90, 92, and 95 through 96.43. The majority of the accidents were overturned vehicle accidents, with vehicles off the road as the second most common accident. Milepost 88 is located between Arrow Point and Neachen Bay and has several tight curve radii and sight distance issues. Milepost 90 includes the Burma Road intersection. Milepost 92 is at the top of the Beauty Bay hill and has several intersections in close proximity. Mileposts 95 and 96 include a boat ramp area and the Interstate 90 junction. The terrain within this segment includes significant horizontal and vertical grade changes as well as tight curve radii.

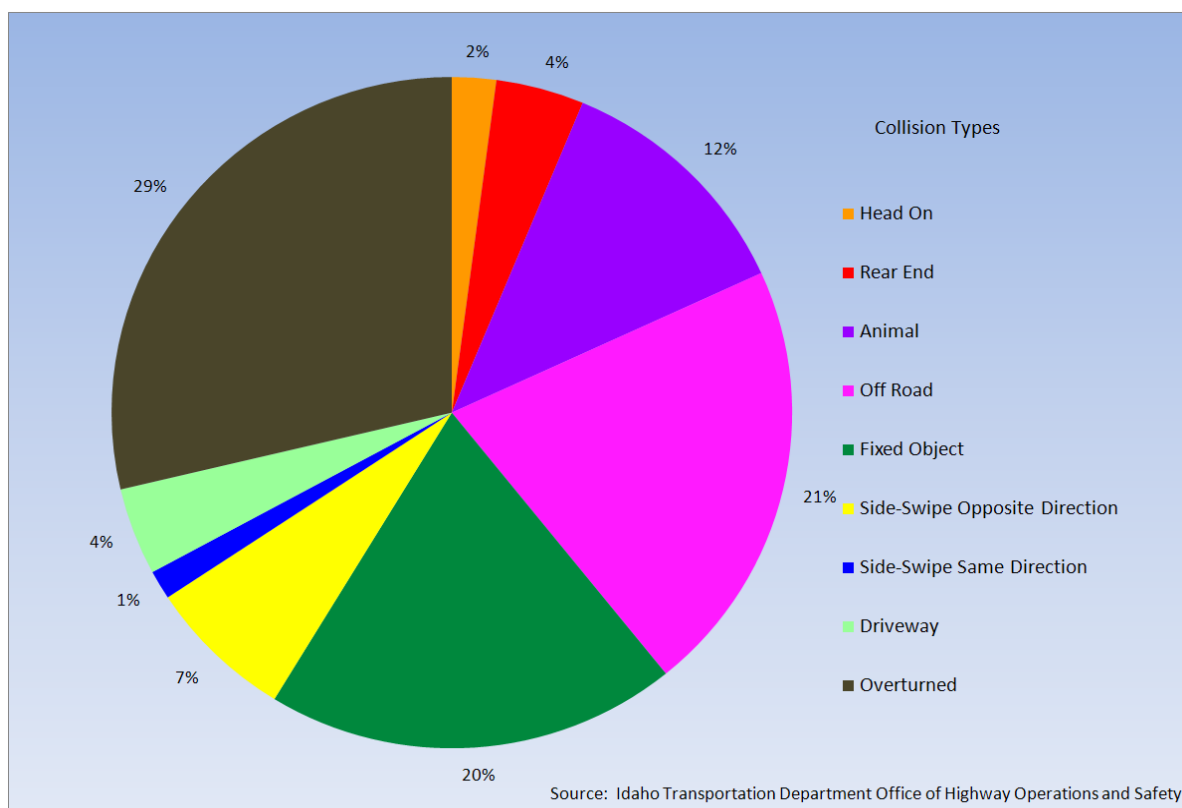
**Table 7. 2001 – 2006 State Highway 97 Total Accidents**

Overall, for the years 2001 through 2006 over the entire study section of SH 97 (Table 7), 29 percent of the total number crashes occurred with overturned vehicles, 21 percent were vehicles resulting off the roadway, and 20 percent occurred with crashes with fixed objects. According to the Institute of Transportation Engineers, Transportation Engineering Handbook (5<sup>th</sup> Edition, 1999) common reasons for these accident types are inadequate shoulders, narrow lanes, inadequate lighting, slippery surfaces, and abrupt horizontal and vertical alignment changes. These reasons are borne out by the majority of accidents indicating that vehicles are leaving the road. There was one fatality for the time-period.

Overall, for the entire study section of SH 97, 29 percent of the total number crashes occurred with overturned vehicles, 21 percent occurred with crashes with fixed objects, and 20 percent were vehicles resulting off the roadway between the years 2001 and 2006. The common reasons for these accident types are inadequate shoulders, narrow lanes, inadequate lighting, slippery surfaces, and abrupt horizontal and vertical alignment changes.

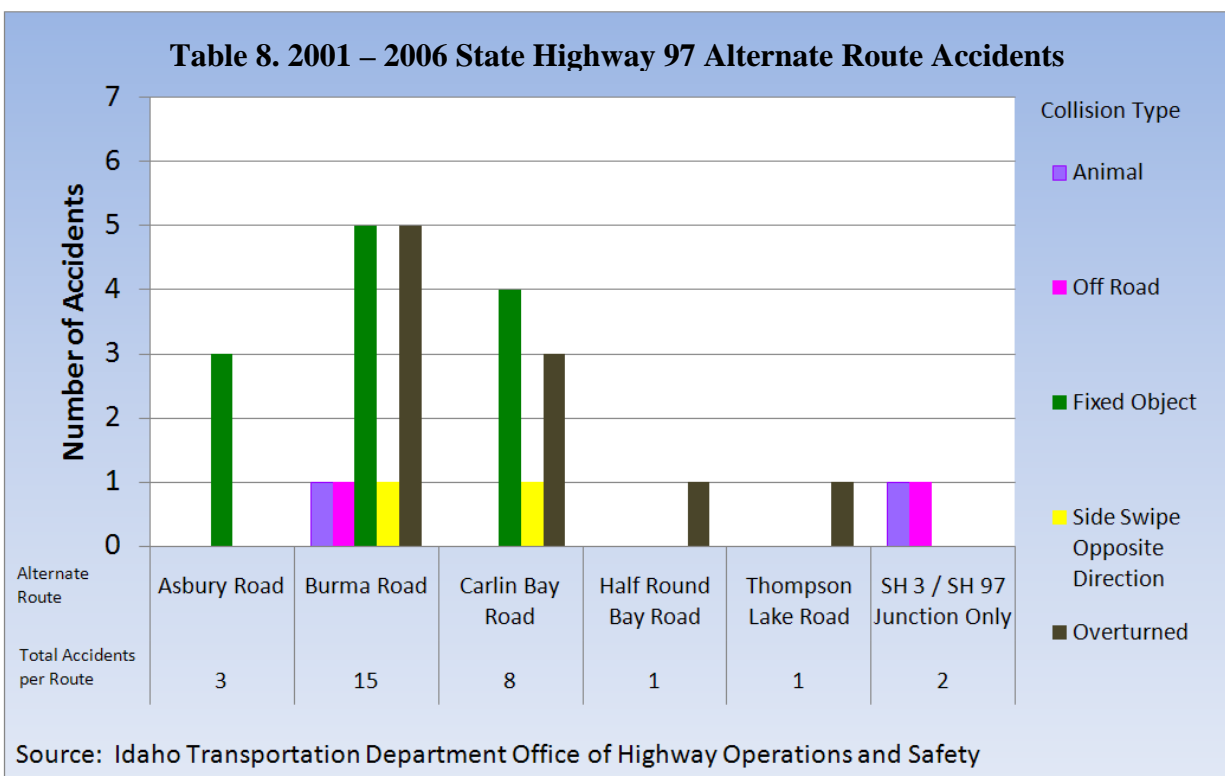
Other roadways connecting to State Highway 97 were analyzed and evaluated for safety for the 2001 through 2006 time-period as alternate routes (Table 8): Burma Road, Carlin Bay Road, Asbury Road, Half Round Bay Road, Gozzer Road, Gotham Bay Road, and East Thompson Lake Road. Half Round Bay Road was not considered as an alternate route for the study, but was included in the accident data review. Accident data for the State Highway 3/State Highway 97 junction only was also reviewed. The alternate routes are listed in order of most to least reported accidents.

- **Burma Road** had fifteen accidents between milepost 100.3 to 104.25. Most accidents were due to drivers trying to negotiate curves with speeds too fast for conditions. These vehicles either hit a tree or overturned. There were no fatalities and six injuries.

- The second highest accident incidence was on **Carlin Bay Road** with eight accidents. Most of these accidents were caused by vehicles trying to negotiate a curve and were left of the centerline with speeds too fast for the conditions, or inattention. Most of the vehicles either hit a tree or overturned and there were no fatalities and one injury.

- The next highest accident location was **Asbury Road** with three accidents. These vehicles were also trying to negotiate a curve and all three vehicles hit a tree. Their speed was generally too fast for the conditions. There were no fatalities or injuries.

- There was one accident on **Half Round Bay Road and Thompson Lake Road**. In the Half Round Bay Road accident, the vehicle overturned trying to negotiate a curve due to inattention. In the Thompson Lake Road accident, the vehicle overturned due to improper backing. There were no injuries or fatalities with these two accidents.

- There were no accidents reported on **Gozzer Road, or Gotham Bay Road**.

There were two accidents at the **State Highway 3/State Highway 97 junction** between mileposts 95.428 and 96.628. Both accidents were trying to negotiate curves and one accident was caused by their speed being too fast for the conditions, and the other accident was caused by an animal. There were no fatalities or injuries. The junction has skewed intersection angles and includes historic signage and a Kootenai County solid waste site, which contributes to turning vehicle movements.
